# Participatory Walkability Study at Public Transport Catchments

## Belgrade, Serbia

April 2024

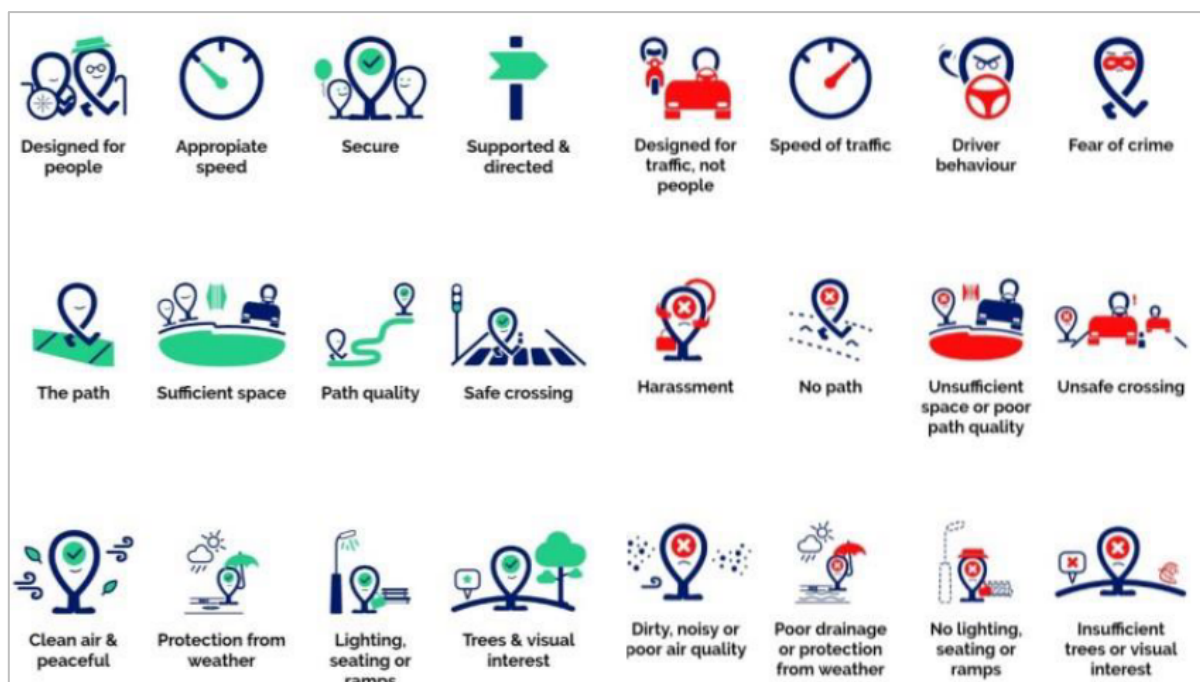
Figure 1. Predefined categories for environmental determinants in the Walkability.App.

4. **Environmental determinants:** Information on the elements and characteristics of the public space that influence pedestrians’ experiences. Participants can describe the public space by using a set of predefined categories on the Walkability App. There are 12 categories linked to positive experiences and 12 for negative experiences and concerns. Refer to Figure X. (The Walkability App also allows inclusion of open text to further describe elements and characteristics of the public space that might not be represented in the predefined categories).

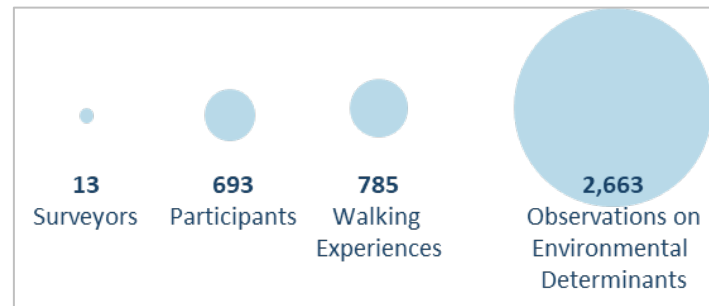
Thirteen university students from Urban Design at the University of Belgrade (Department of Landscape Architecture and Horticulture, Faculty of Forestry) were trained in the use of the Walkability App as a survey tool to interview 693 participants in ten different study areas in Belgrade, Serbia, for two weeks (28/02/2024 – 14/03/2024). As a result, participants shared 785 walking experiences related to 2,663 environmental determinants observed in the public space.

Figure 4. Summary of data collected.

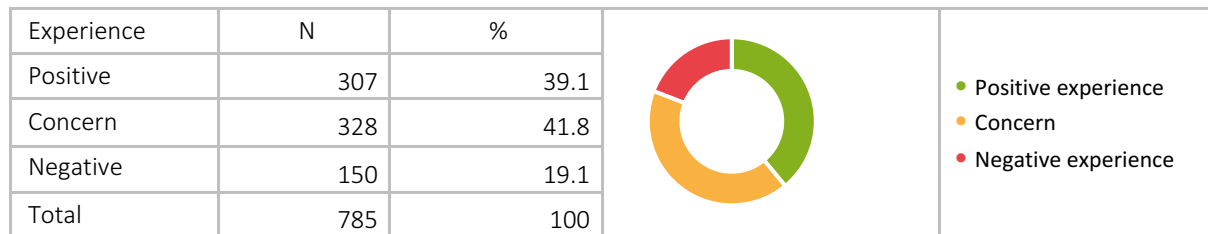
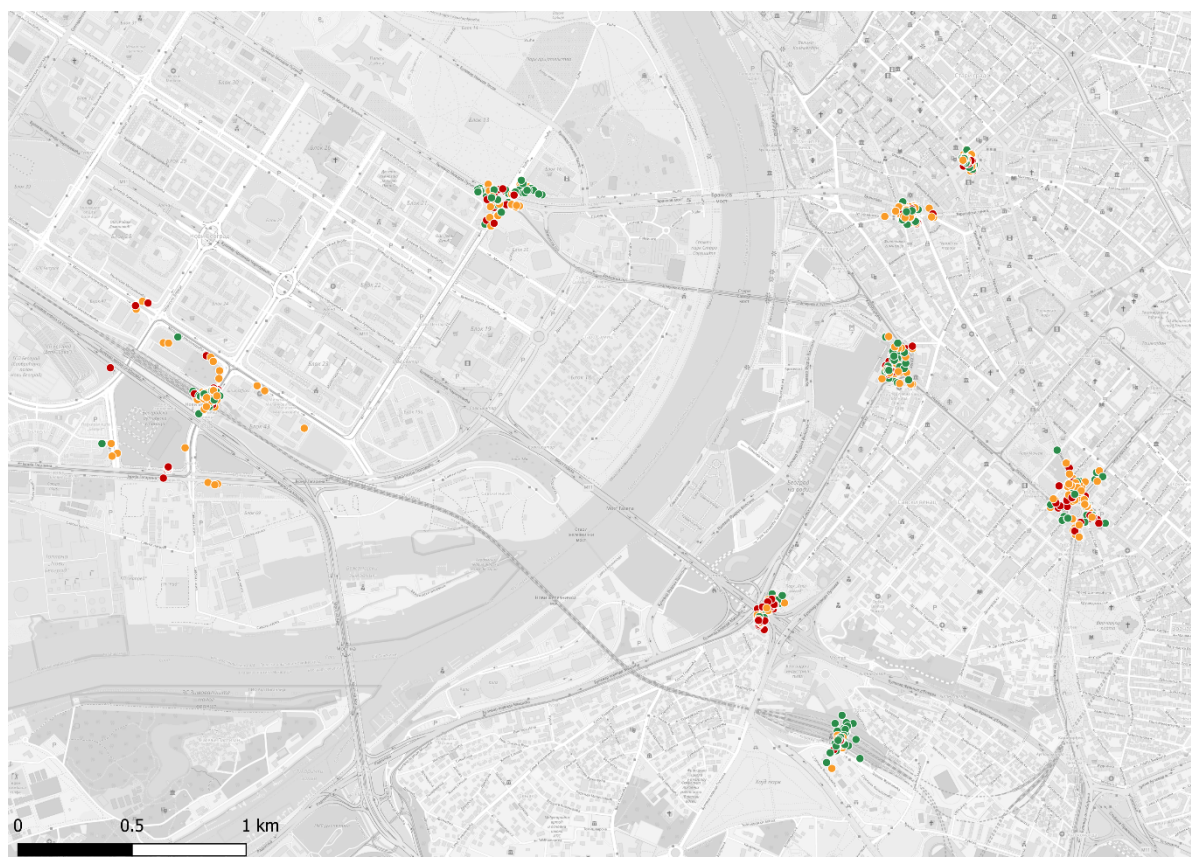
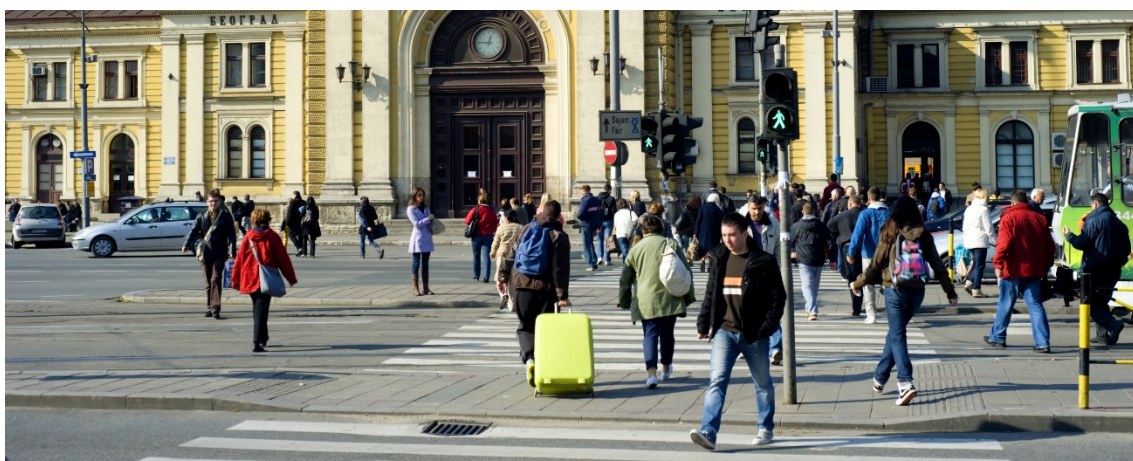
Figure 7. Experiences in Belgrade.

In Belgrade, most of the walking experiences were concerns (41.8%), related to 'Insufficient trees or visual interest' (5.5%), 'Dirty, noisy or poor air quality' (5.2%) and 'Unsafe crossings' (3.8%). Followed by positive experiences (39.1%) related to 'Security' (6.4%), 'Lighting, seating or ramps' (5.1%) and 'Designed for people' (4.3%). And finally, negative experiences (19.1%), related to 'Dirty, noisy or poor air quality' (3.1%), 'Unsafe crossing' (2.3%) and 'Designed for traffic' (2.2%).

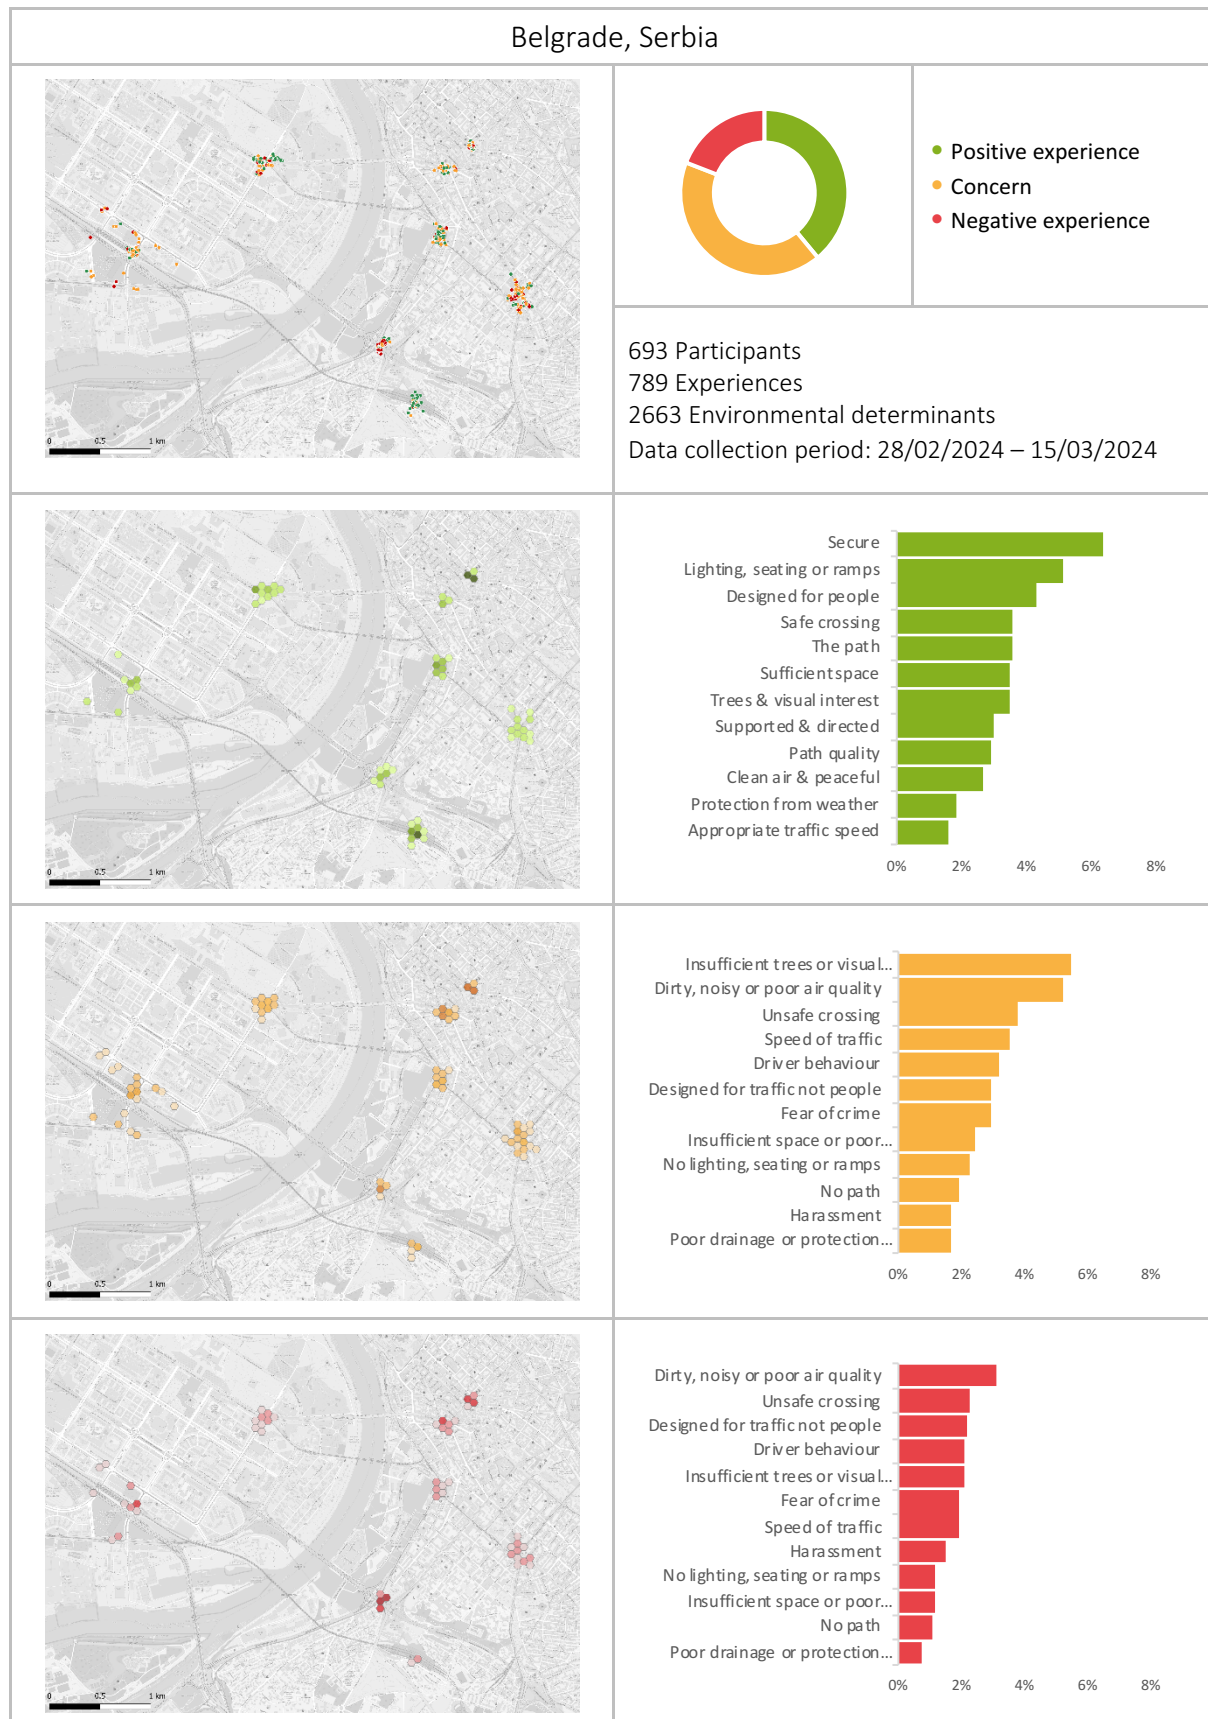
Figure 8. Most relevant determinants by type of experience in Belgrade.

For negative experiences and concerns, 'Dirty, noisy or poor air quality' was the most frequent determinant with 222 observations (8.3%), of which 139 were related to concerns (5.2%) and 83 to negative experiences (3.1%). The second most frequent negative determinant was 'Insufficient trees or visual interest' with 202 observations (7.6%), of which 147 were related to concerns (5.5%) and 55 to negative experiences (2.1%). The third most frequent determinant was 'Unsafe crossing' with 160 observations (6.1%), of which 100 were related to concerns (3.8%) and 60 to negative experiences (2.3%). The fourth most frequent determinant was 'Traffic speed' with 144 observations (5.4%), of which 94 observations were related to concerns (3.5%) and 50 to negative experiences (1.9%). Finally, this top-five list ends with 'Driver behaviour' with 139 observations (5.3%), of which 84 were related to concerns (3.2%) and 55 to negative experiences (2.1%).

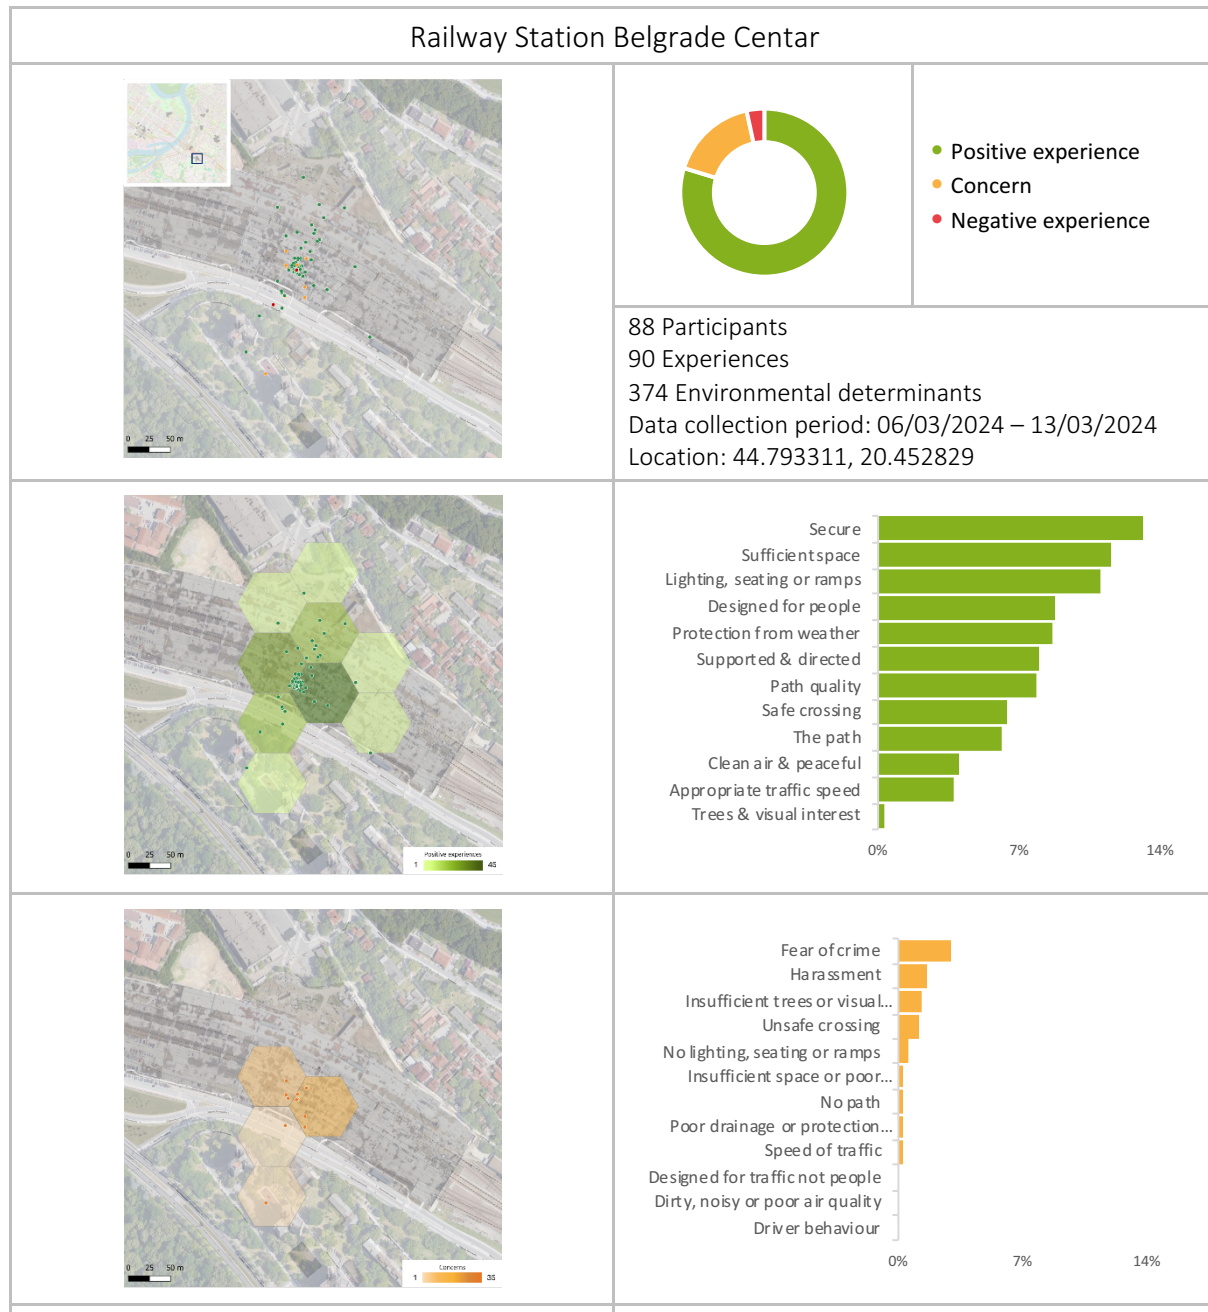
Figure 42. Most relevant determinants by type of experience at Railway Station Belgrade Centar.

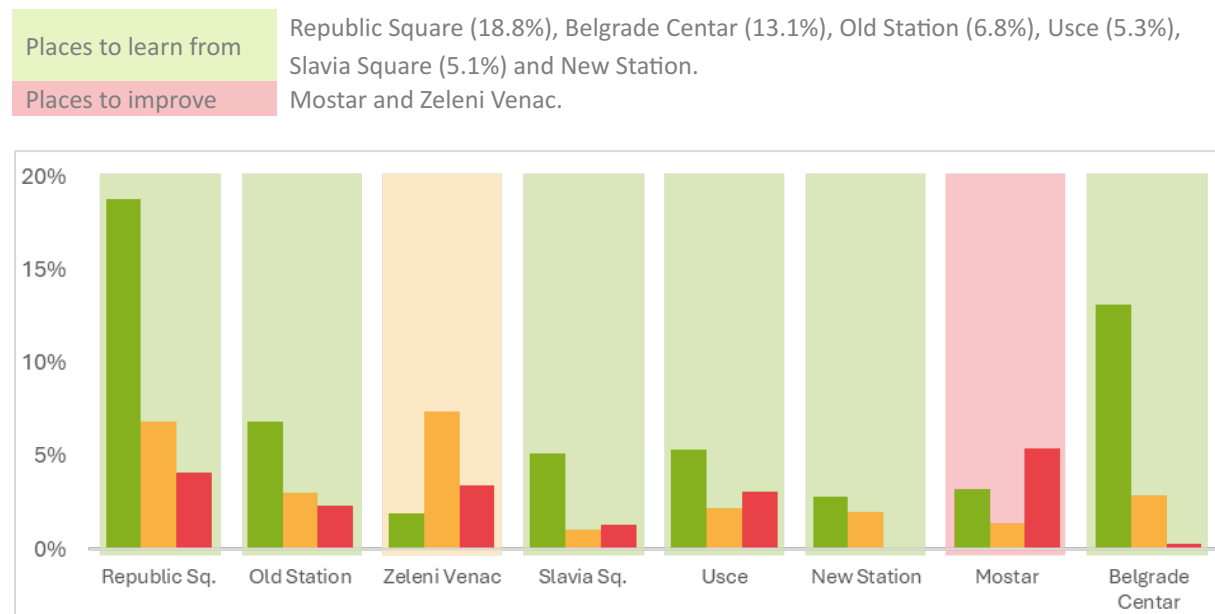
Figure 45. Experiences related to personal security by study areas.

Personal security was the most frequent determinant (11.2%) related to walking experiences in Belgrade, with 6.4% related to positive experiences. However, 2.9% were related to concerns and 1.9% to negative experiences due to fear of crime. By study area, there were six areas with more positive experiences: Republic Square (18.8%), Belgrade Centar (13.1%), Old Station (6.8%), Usce (5.3%), Slavia Square (5.1%) and New Station (2.8%). There was one area with more concerns: Zeleni Venac (7.4%) and one are with more negative experiences: Mostar (5.4%).

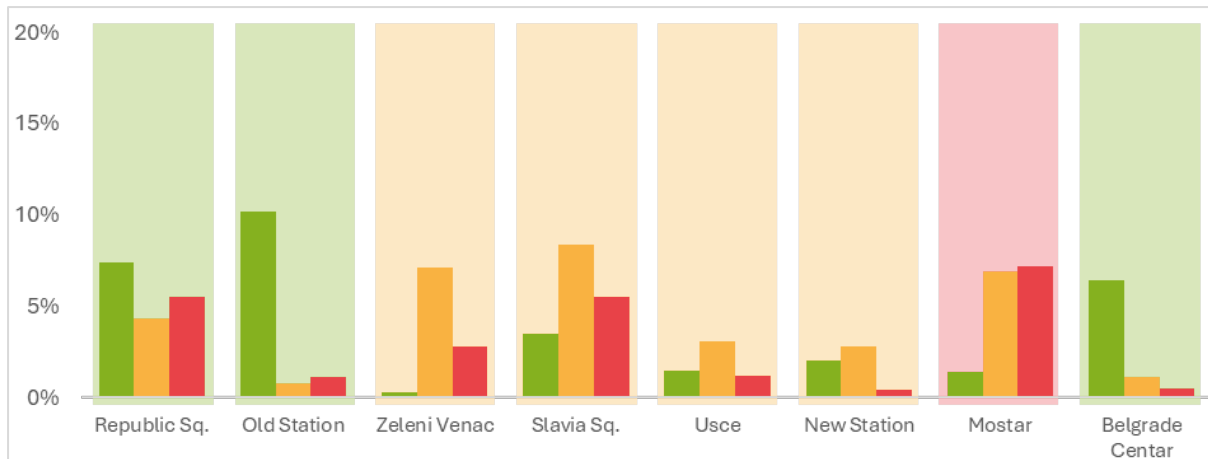
Figure 49. Experiences related to pedestrian crossings by study areas.

Pedestrian crossings were the fifth more frequent determinant (9.7%) related to walking experiences in Belgrade, with 3.8% related to negative experiences and 2.3% to concerns due to unsafe crossings. On the other hand, 3.6% were related to positive experiences thanks to safe crossings. By study area, there were four areas with more concerns: Slavia Square (8.4%), Zeleni Venac (7.1%), Usce (3.1%) and New Station (2.8%). There was one area with more negative experiences: Mostar (7.2%). Finally, there were three areas with more positive experiences: Old Station (10.2%), Republic Square (7.4%) and Belgrade Centar (6.4%).

Places to learn from	Old Station, Republic Square and Belgrade Centar.
Places to improve	Mostar, Slavia Square, Zeleni Venac, Usce and New Station.

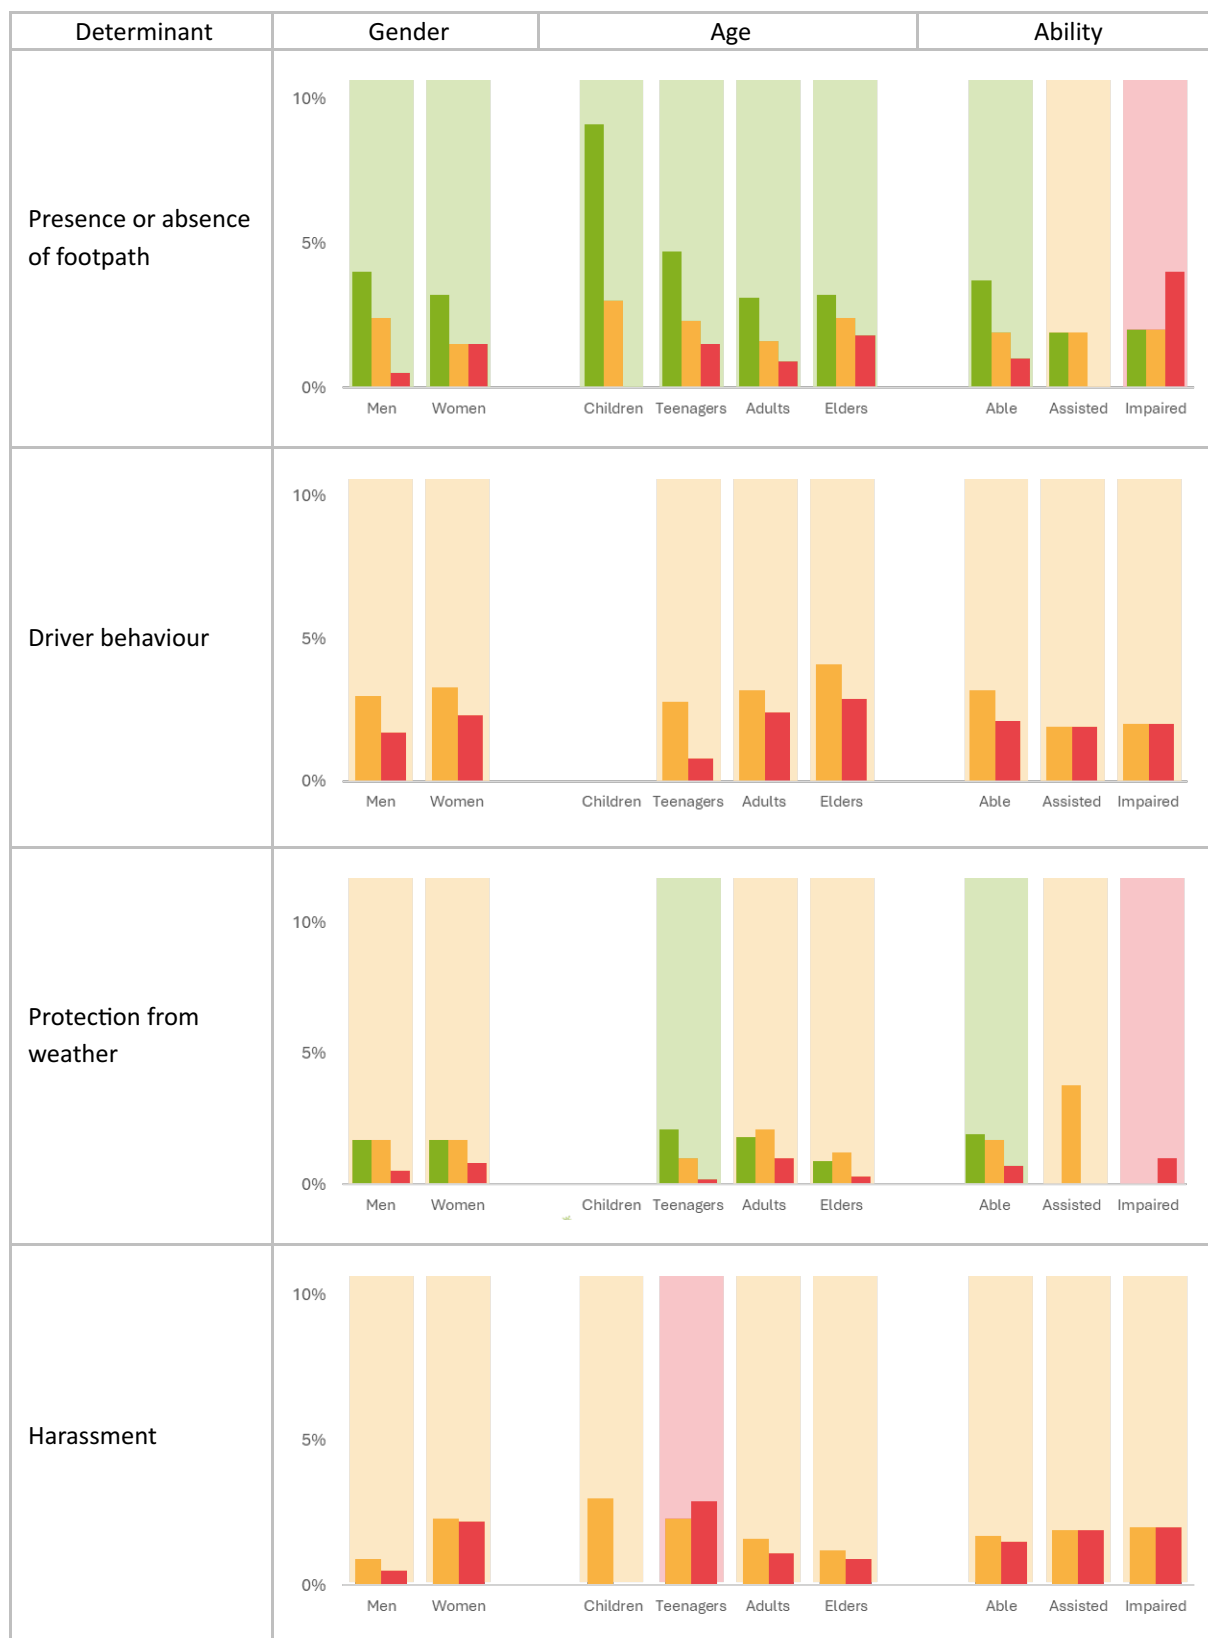
Table 13. Most frequent type of experience related to determinants by pedestrian profile (3/3).
