WALKABILITY

Walkability Safety Assessment Kigali, Rwanda

June 2024

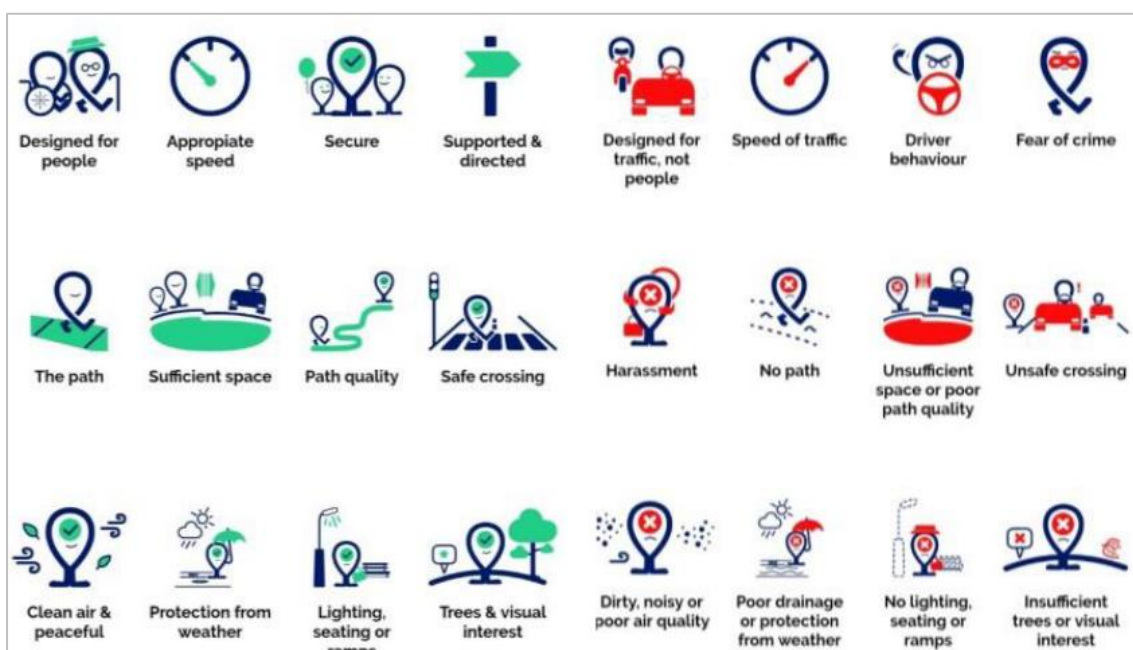
Figure 1. Predefined environmental determinants from the Walkability App.

- 4. Environmental determinants:** Information on the elements and characteristics of the public space that influence pedestrians’ experiences. Participants can describe the public space by using a set of predefined categories on the Walkability App. There are 12 categories linked to positive experiences and 12 for negative experiences and concerns. The Walkability App also allows inclusion of open text to further describe elements and characteristics of the public space that might not be represented in the predefined categories.

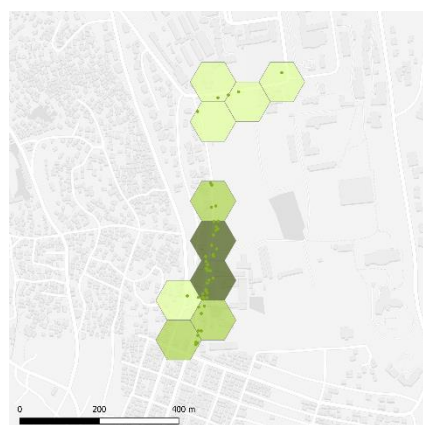
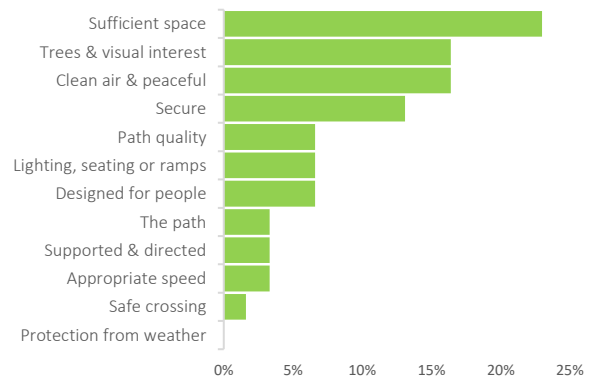
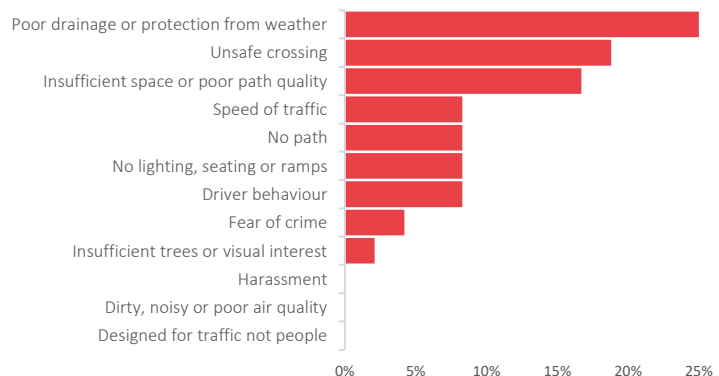
Figure 24. Camp Kigali School, experiences and determinants.

In Camp Kigali School, most of the walking experiences were positive (39.5%) and related to 'Sufficient space' (23%), 'Trees and visual interest' (16.4%) and 'Clean and peaceful' (16.4%). Followed by concerns (35.5%) related to 'Unsafe crossing' (22.6%), 'Poor weather protection' (21%) and 'Driver behaviour' (16.1%). And finally, negative experiences (25%), related to 'Poor protection from weather' (25%), 'Unsafe crossing' (1.8%) and 'Insufficient space or poor path quality' (16.7%).

Relationships between environmental determinants and walking experiences in Camp Kigali School.

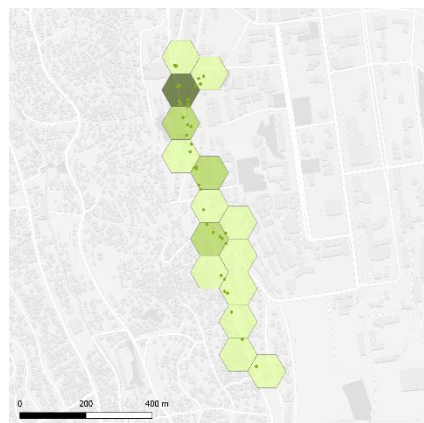
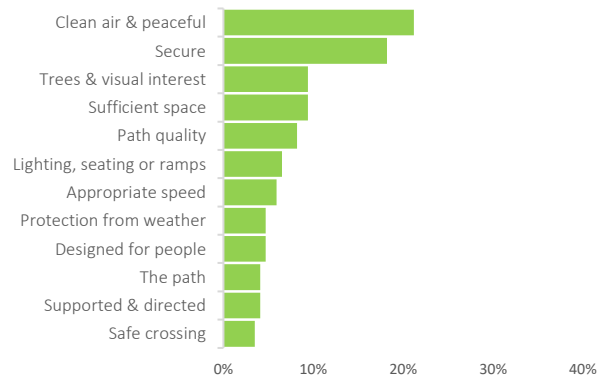
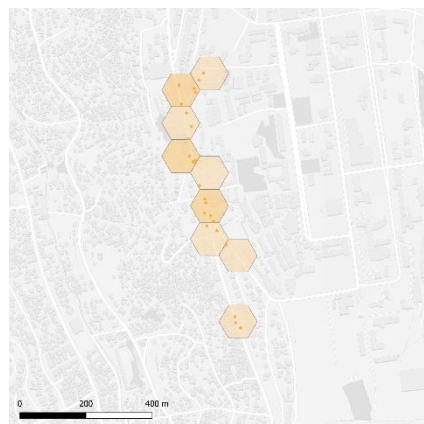
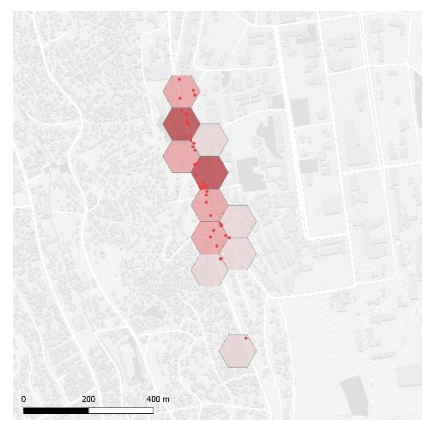
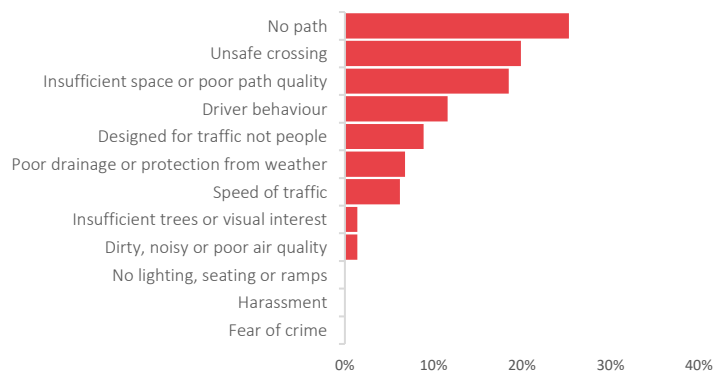
Figure 26. Groupe Scholaire EPA-St Michel Nyarugenge, experiences and determinants.

In Groupe Scholaire EPA-St Michel Nyarugenge, most of the walking experiences were negative (41.4%) and related to 'No path' (25.3%), 'Unsafe crossing' (19.9%) and 'Insufficient space or poor path quality' (18.5%). Followed by positive experiences (37.1%) related to 'Clean and peaceful' (21.2%), 'Secure' (18.2%) and 'Trees and visual interest' (9.4%). And finally, concerns (21.6%), related to 'Insufficient space or poor path quality' (38.9%), 'Unsafe crossing' (22.2%) and 'Poor protection from weather' (9.3%).

Relationships between environmental determinants and walking experiences in Groupe Scholaire EPA- St Michel Nyarugenge.

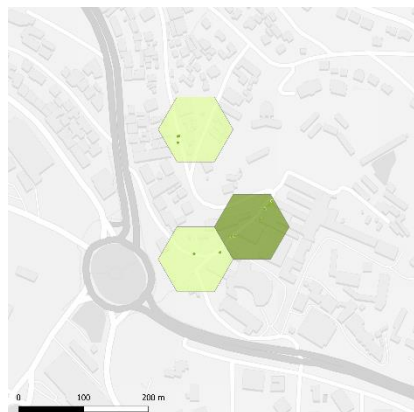
Figure 30. St. Joseph Le Travailleur Secondary School, experiences and determinants.

In St. Joseph Le Travailleur Secondary School, most of the walking experiences were concerns (47.1%) and related to 'Poor protection from weather' (19.4%), 'Unsafe crossing' (16.7%) and 'Insufficient space or poor path quality' (14%). Followed by negative experiences (37.9%) related to 'Unsafe crossing' (19%), 'Poor protection from weather' (19%) and 'Insufficient space or poor path quality' (13.5%). And finally, positive experiences (14.9%), related to 'Clean and peaceful' (31.4%), 'Trees and visual interest' (20%) and 'Lighting, seating or ramps' (17.1%).

Relationships between environmental determinants and walking experiences in St. Joseph Le Travailleur Secondary School.

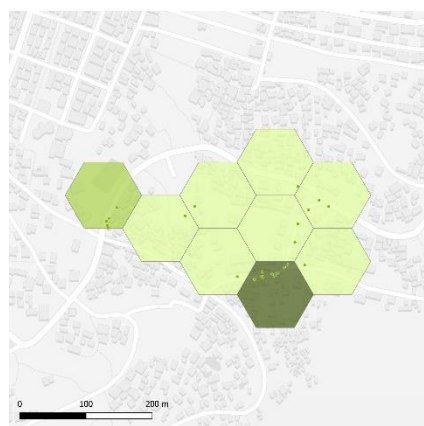
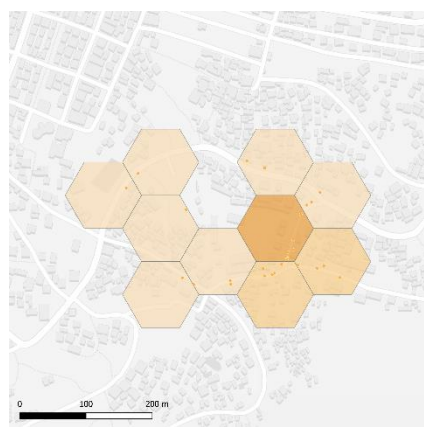
Figure 32. Biryogo Primary School, experiences and determinants.

In Biryogo Primary School, most of the walking experiences were negative (37.8%) and related to 'Poor protection from weather' (21.2%), 'Speed of traffic' (19.5%) and 'Designed for traffic' (15.3%). Followed by concerns (33.3%) related to 'Speed of traffic' (22.4%), 'Unsafe crossing' (21.4%) and 'Poor protection from weather' (18.4%). And finally, positive experiences (28.9%), related to 'Clean and peaceful' (24.7%), 'Lighting, seating or ramps' (16.9%) and 'Path quality' (13.5%).

Relationships between environmental determinants and walking experiences in Biryogo Primary School.

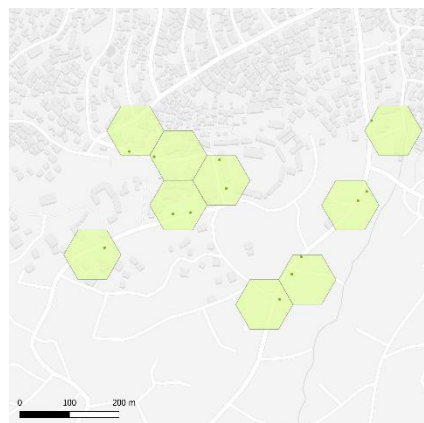
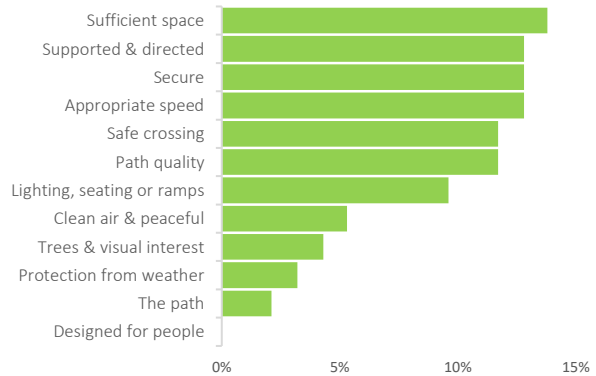
Figure 34. Kabusunzu Primary School, experiences and determinants.

In Kabusunzu Primary School, most of the walking experiences were negative (56%) and related to 'Insufficient space or poor path quality' (14.4%), 'Unsafe crossing' (14.1%) and 'Poor protection from weather' (14.1%). Followed by concerns (31%) related to 'Insufficient space or poor path quality' (14.1%), 'No lighting, seating or ramps' (13.6%) and 'Unsafe crossing' (13.1%). And finally, positive experiences (13%), related to 'Sufficient space' (13.8%), 'Supported and directed' (12.8%) and 'Secure' (12.8%).

Relationships between environmental determinants and walking experiences in Kabusunzu Primary School.

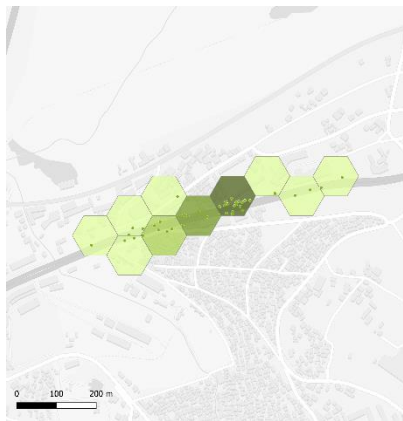
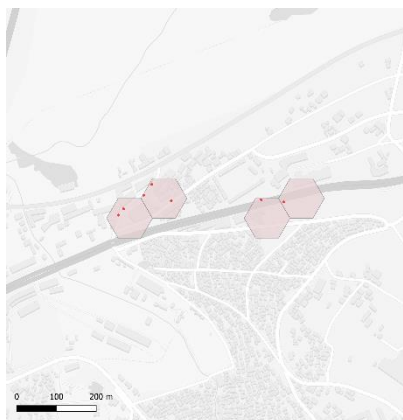
Figure 36. Muhima Primary School, experiences and determinants.

In Muhima Primary School, most of the walking experiences were positive (46.9%) and related to 'Sufficient space' (14.6%), 'Path quality' (14.6%) and 'Lighting, seating or ramps' (13.9%). Followed by concerns (45.8%) related to 'Unsafe crossing' (16.9%), 'Insufficient trees or visual interest' (13.1%) and 'Driver behaviour' (12.2%). And finally, negative experiences (7.3%), related to 'Driver behaviour' (12.5%), 'Unsafe crossing' (10.4%) and 'Speed of traffic' (10.4%).

Relationships between environmental determinants and walking experiences in Muhima Primary School.

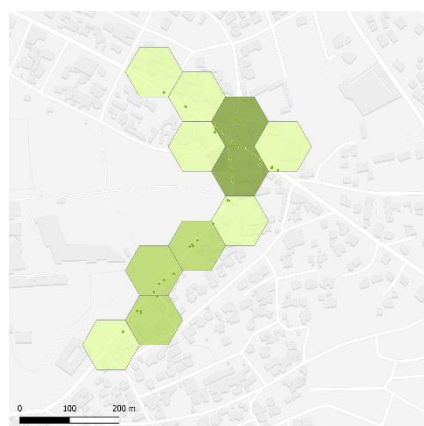
Figure 38. Kicukiro Primary School, experiences and determinants.

In Kicukiro Primary School, most of the walking experiences were positive (43.2%) and related to 'Suffieint space' (15.3%), 'Lighting, seating or ramps' (14.7%) and 'clean and peaceful' (14%). Followed by negative experiences (34.1%) related to 'Poor protection from weather' (24%), 'Insufficient trees or visual interest' (18.7%) and 'Unsafe crossing' (17.3%). And finally, concerns (22.7%), related to 'Driver behaviour' (20%), 'Unsafe crossing' (16.7%) and 'Insufficient space or poor path quality' (16.7%).

Relationships between environmental determinants and walking experiences in Kicukiro Primary School.

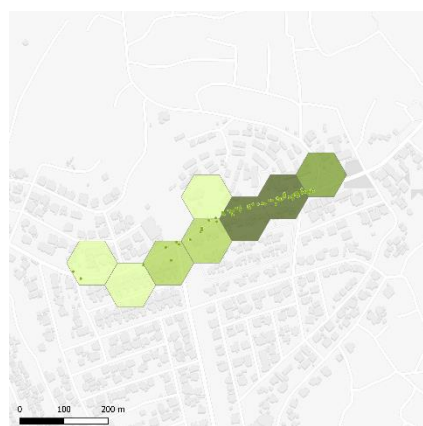
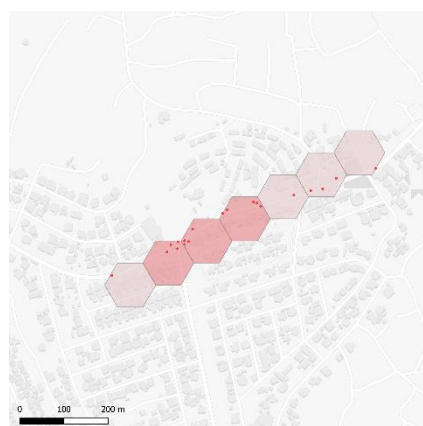
Figure 42. FAWE Girls School, experiences and determinants.

In FAWE Girls School, most of the walking experiences were positive (46.9%) and related to 'Presence of footpath' (19.3%), 'Trees and visual interest' (15.5%) and 'Lighting, seating or ramps' (14.6%). Followed by concerns (39.9%) related to 'Unsafe crossing' (37.2%), 'Speed of traffic' (19.3%) and 'Driver behaviour' (13.8%). And finally, negative experiences (13.3%), related to 'Unsafe crossing' (30%), 'Speed of traffic' (23.3%) and 'Dirty, noisy or poor air quality' (13.3%).

Relationships between environmental determinants and walking experiences in FAWE Girls School.

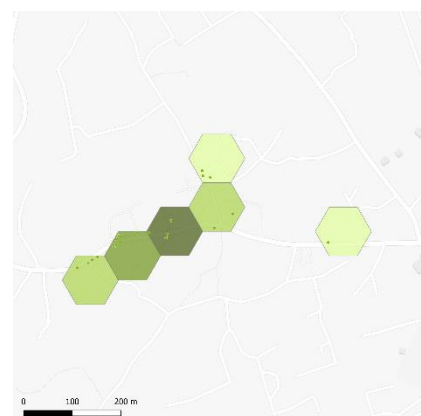
Figure 44. Saint Dominic Primary School, experiences and determinants.

In Saint Dominic Primary School, most of the walking experiences were positive (43.7%) and related to 'Trees and visual interest' (25.9%), 'Lighting, seating or ramps' (16%) and 'Clean and peaceful' (13.6%). Followed by concerns (42.3%) related to 'Insufficient space or poor path quality' (29.7%), 'Poor protection from weather' (20.3%) and 'Speed of traffic' (12.2%). And finally, negative experiences (14.1%), related to 'No lighting, seating or ramps' (19%), 'Poor protection from weather' (14.3%) and 'Insufficient space or poor path quality' (14.3%).

Relationships between environmental determinants and walking experiences in Saint Dominic Primary School.

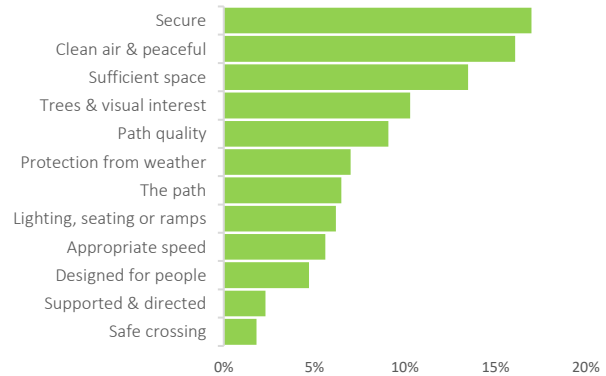
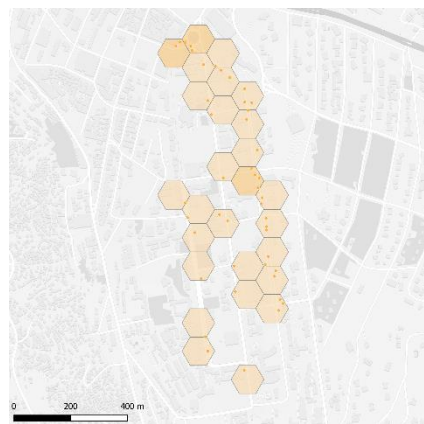
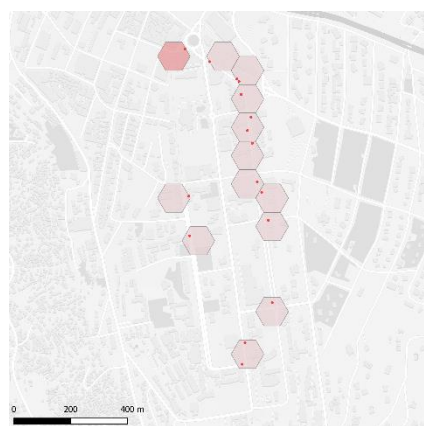
Figure 46. University of Rwanda, experiences and determinants.

In University of Rwanda, most of the walking experiences were positive (50.4%) and related to 'Secure' (17%), 'Cleaning and peaceful' (16.1%) and 'Sufficient space' (13.5%). Followed by concerns (37%) related to 'Unsafe crossing' (30.6%), 'No footpath' (16.2%) and 'Insufficient space or poor path quality' (16.2%). And finally, negative experiences (12.6%), related to 'Unsafe crossing' (26.2%), 'No footpath' (23.8%) and 'Poor protection from weather' (14.3%).

Relationships between environmental determinants and walking experiences in University of Rwanda.

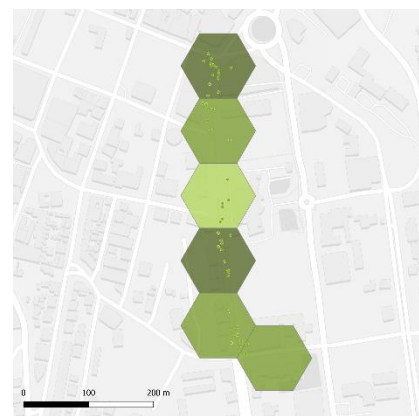
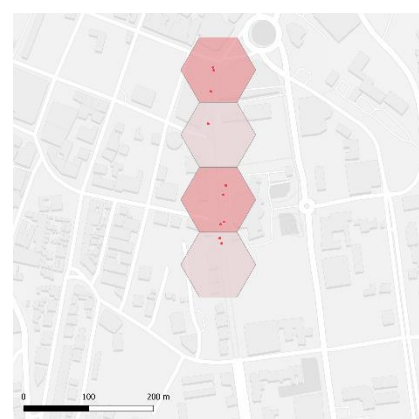
Figure 48. KN 4 Avenue – Pedestrianised area, experiences and determinants.

In KN 4 Avenue - Pedestrianised area, most of the walking experiences were positive (64.6%) and related to 'Designed for people' (13.3%), 'Clean and peaceful' (12.7%) and 'Sufficient space' (11.6%). Followed by concerns (23.2%) related to 'Insufficient space or poor path quality' (44.8%), 'Poor protection from weather' (41.4%) and 'No lighting, seating or ramps' (6.9%). And finally, negative experiences (12.2%), related to 'Insufficient space or poor path quality' (42.1%), 'Poor protection from weather' (36.8%) and 'No lighting, seating or ramps' (15.8%).

Relationships between environmental determinants and walking experiences in KN 4 Avenue – Pedestrianised area.

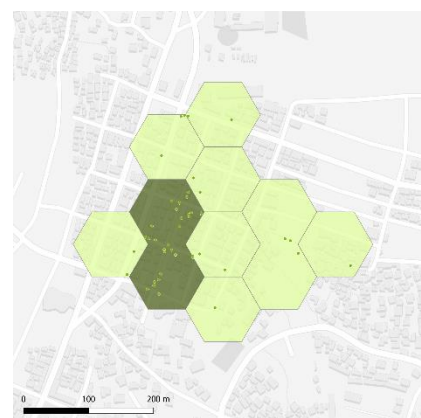
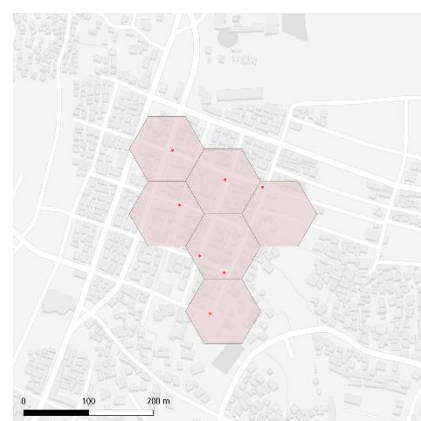
Figure 50. Biryogo Car Free Food Street, experiences and determinants.

In Biryogo Car Free Food Street, most of the walking experiences were positive (57.8%) and related to 'Lighting, seating or ramps' (22.7%), 'Clean air and peaceful' (21.2%) and 'Designed for people' (17.7%). Followed by concerns (32.5%) related to 'Insufficient trees or visual interest' (36.7%), 'Insufficient space or poor path quality' (23.3%) and 'Unsafe crossing' (16.7%). And finally, negative experiences (9.6%), related to 'Insufficient trees or visual interest' (41.2%), 'Unsafe crossing' (23.5%) and 'Insufficient space or poor path quality' (11.8%).

Relationships between environmental determinants and walking experiences in Biryogo Car Free Food Street.

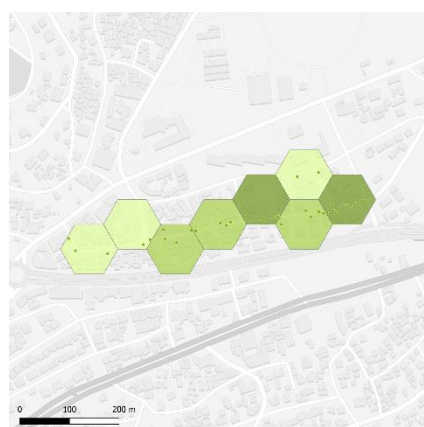
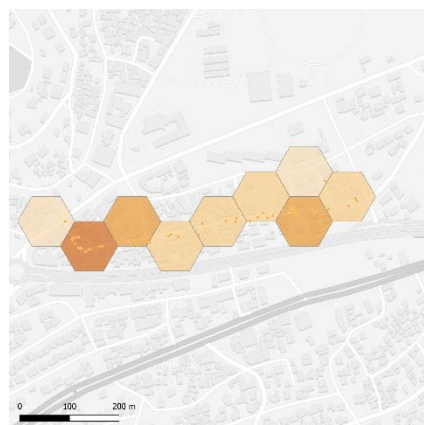
Figure 52. Remera Gisimenti Car Free Zone, experiences and determinants.

In Remera Gisimenti Car Free Zone, most of the walking experiences were concerns (45.6%) and related to 'Insufficient trees or visual interest' (23.2%), 'Poor protection from weather' (14.4%) and 'Insufficient space or poor path quality' (14.4%). Followed by positive experiences (36.9%) related to 'Secure' (14.9%), 'Clean air and peaceful' (12.5%) and 'Sufficient space' (11.3%). And finally, negative experiences (17.5%), related to 'No footpath' (26.8%), 'Unsafe crossing' (21.4%) and 'Poor protection from weather' (17.9%).

Relationships between environmental determinants and walking experiences in Remera Gisimenti Car Free Zone.
